Test Report No. CANEC1700761401 Date: 20 Jan 2017 Page 1 of 4

The following sample(s) was/were submitted and identified on behalf of the clients as: 2016 LED Flash Light

Test Requested: Selected test(s) as requested by client.

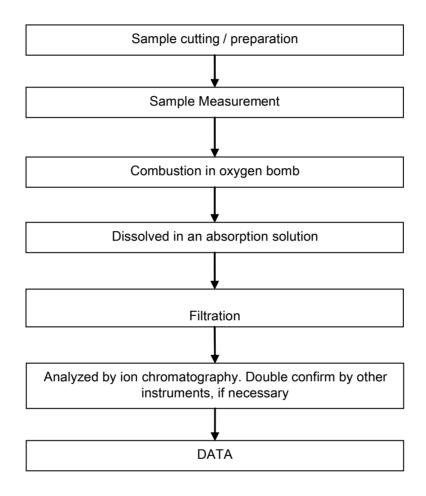
Halogen Testing Flow Chart

Test Method: With reference to EN 14582:2016, analysis was performed by IC.

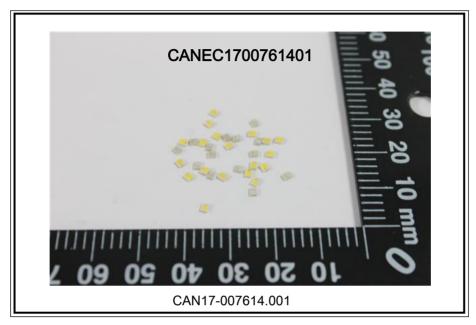
Sample photo:

> CAN17-007614.001 SN₁ "2016 LED Flash Light"
